# Repairing Mitsubishi WS-65511 Blinking green light fuse replacement

Repair of the green blinking light by replacing the capacitors on the DM board. This repair can also be performed on the following models: V21 MODELS WS-48511 WS-55511 WS-65511 WS-B55 V21+ MODELS WS-65611 V21++ MODELS WS-55711 WS-65711 WS-6571

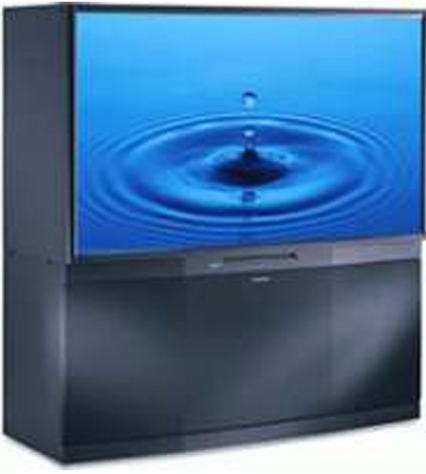
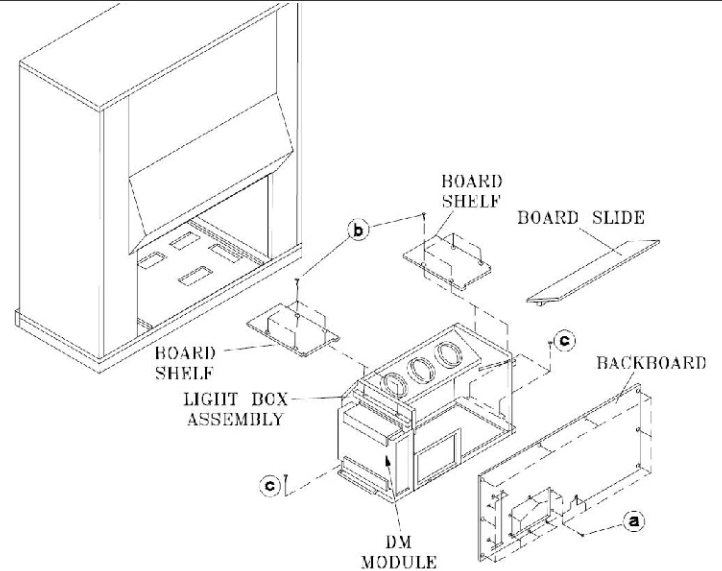
## Step 1 — Repairing Mitsubishi WS-65511 Blinking green light fuse replacement

- Unplug the set. disconnect the coax cable and any other device plugged into the TV.
- Remove the back panel
- The antenna coax cable as well as other device connect directly to the DM module which is enclosed in a metal case.

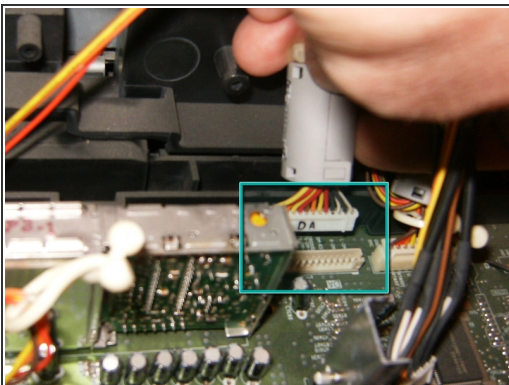
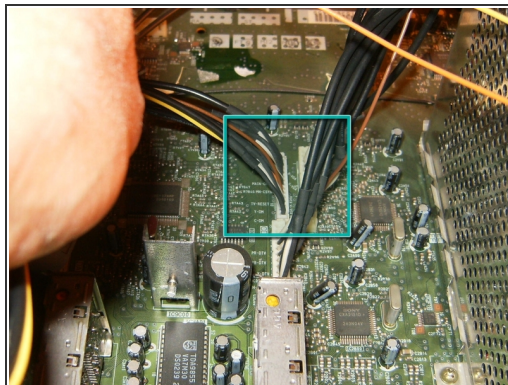
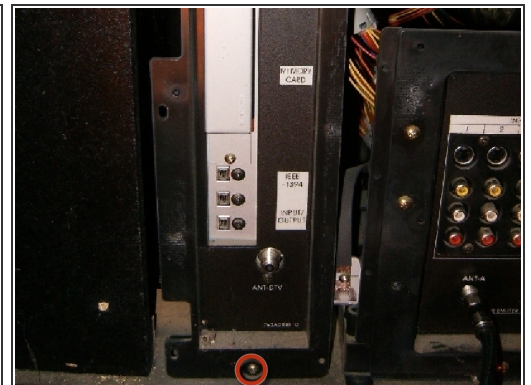
## Step 2

- Disconnect the wiring coming off the DM board to the main chassis. On this TV there were four separate wiring harnesses: DA,VA,DB and PF. These markings are **not** of importance to this repair. But they all are clearly marked on the connectors as well as the logic board they connect to. This will help to identify their proper position for the re-assembly.
- Undo the two screws that hold the plastic cover to the DM board.

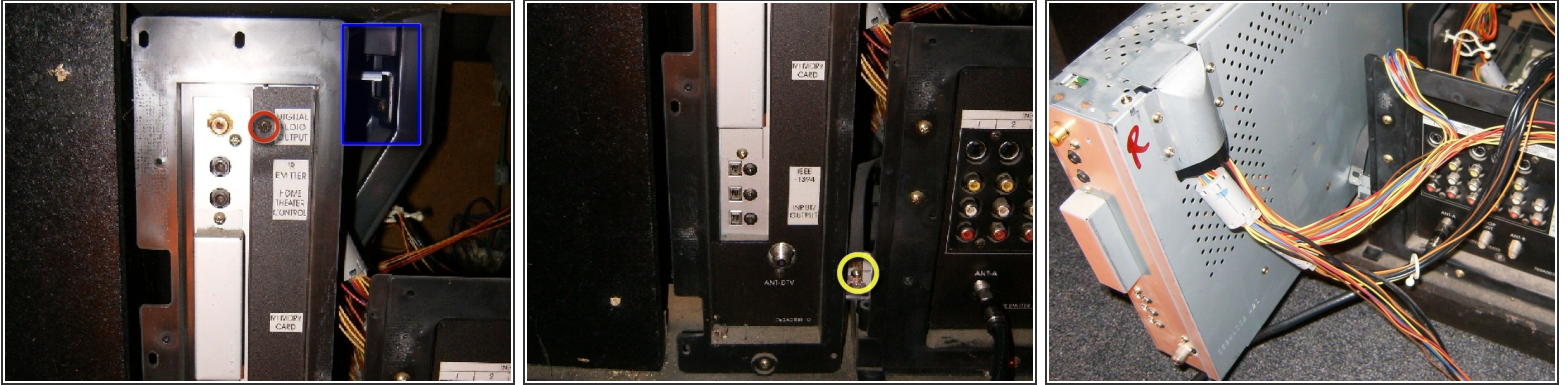
## Step 3

- To the bottom right is a screw that connects a ground strap and holds the board to the chassis, undo that.
- With all the connector disconnected, the ground strap removed, pull the DM board carefully from the chassis. Some models have a small tab stop that you must push down to release the board.

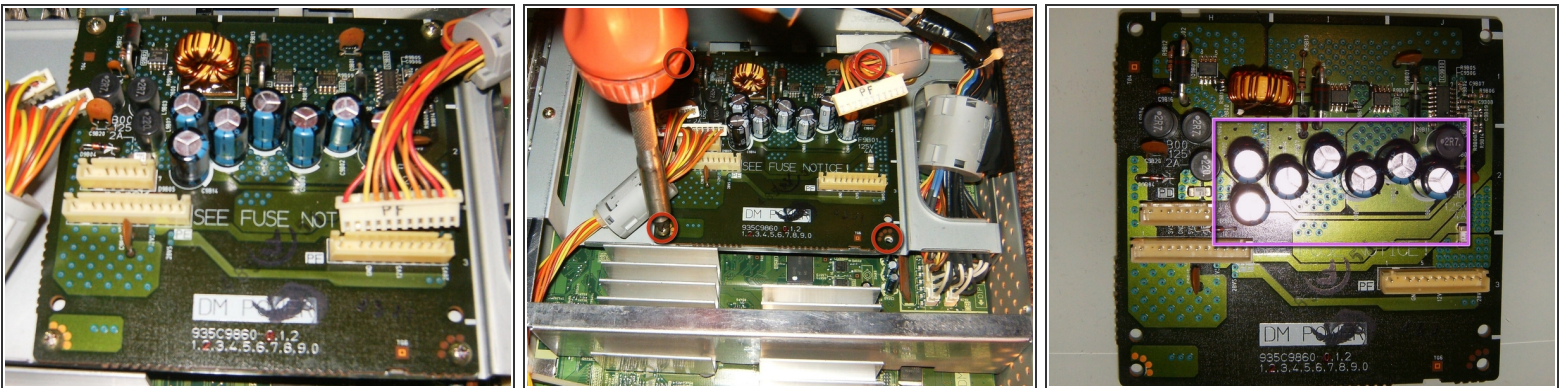
## Step 4

- Remove the wiring attached to it (PD,PE,PF). These are simple connector and can just pulled of. These markings are **not** of importance to this repair. But they all are clearly marked on the connectors as well as the logic board they connect to. This will help to identify their proper position for the re-assembly.
- Remove the four screws holding the board on.
- This board has 7 1000uf 16Volt capacitors. These are the ones that have a tendency of failing. Inspect those for bulging tops as well as leakage. In this case, one capacitors was slightly bulged.

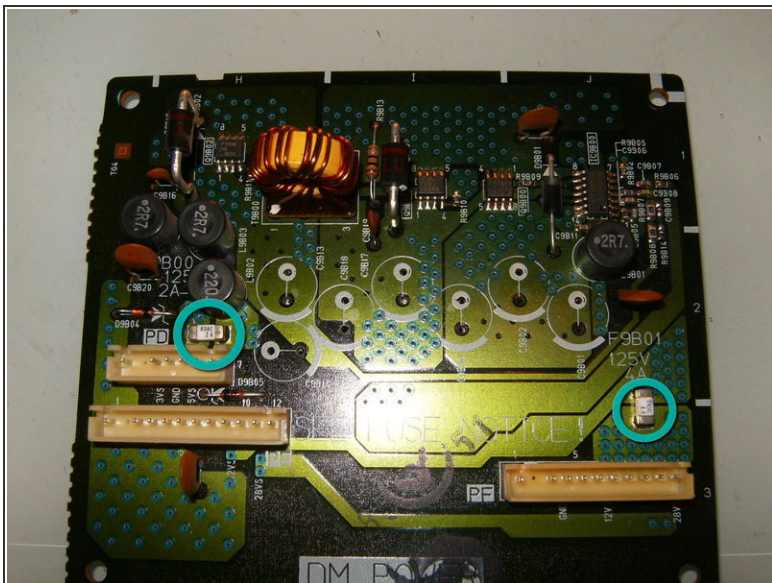
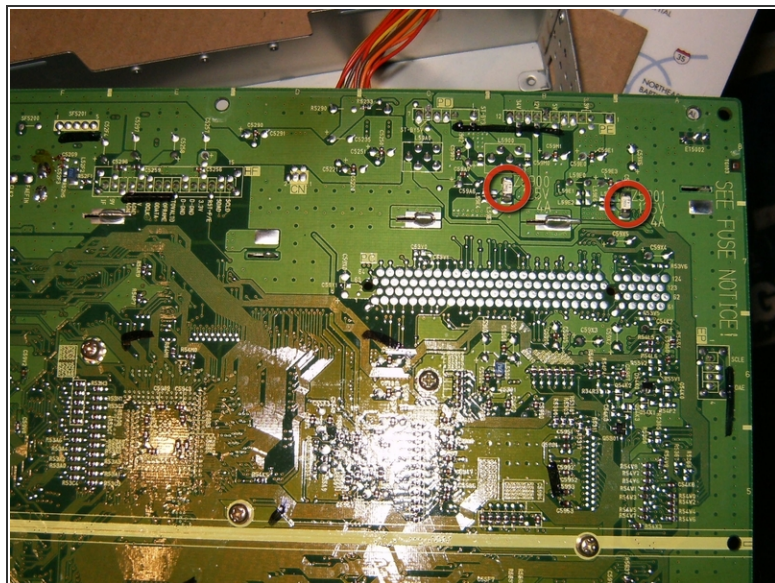
## Step 6

- While the board and the DM power module are accessible check the SMD fuses for continuity. There are two on the daughter board. In this case, the fuses had continuity and were functioning.
- The main PCB has two fuses on the **underside**. In order to get to it, one will have to disassemble the module further. This was skipped in this repair.
